RSC Sub-committee To Investigate and Review ALS Shielding Control Procedures

RSC Sub-committee – Report

Wednesday, 18 January 2006

I. EXECUTIVE SUMMARY

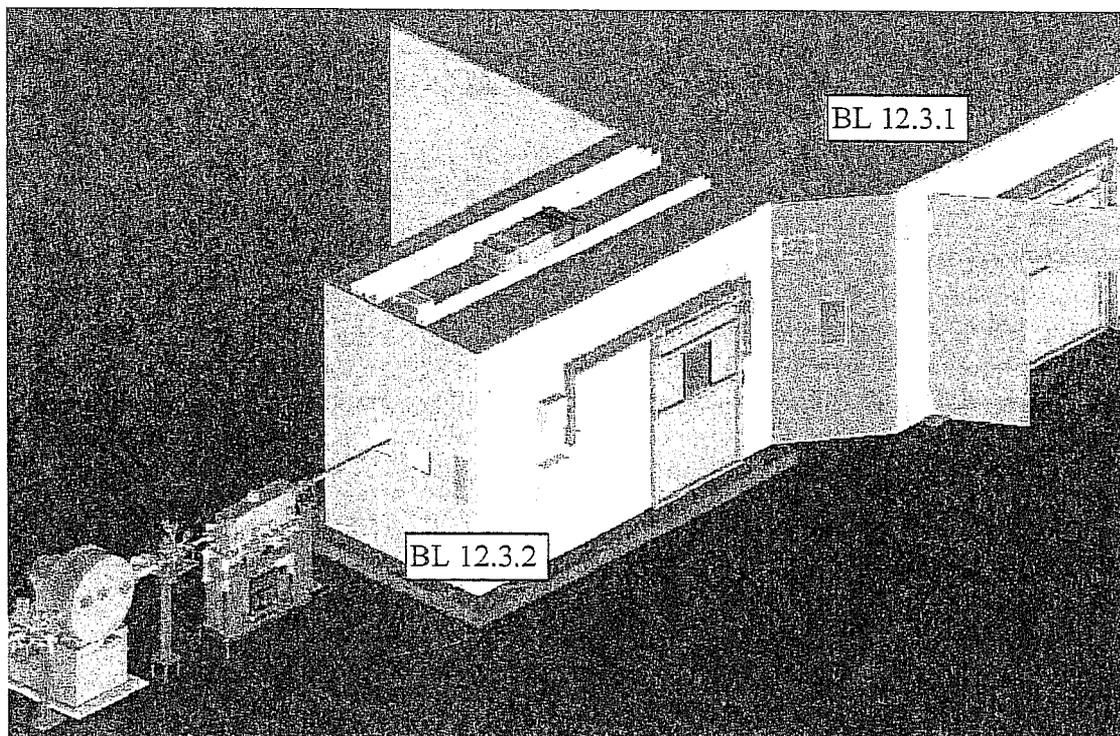
To complete the new 12.3.2 hatch, the 12.3.1 labyrinth needed to be replaced with a lead lined labyrinth to ensure that when 12.3.2 was operating there would be no radiation hazard to anyone inside the 12.3.1 hatch. For this purpose, the plan was to complete a shielding change form, key-off BL 12.3.1, drill new mounting holes in the 12.3.1 hatch and install the new lead-lined labyrinth. However the need to remove the existing labyrinth at the early stages of the new hatch installation was not anticipated.

Figure 2. 12.3.2 hatch assembly details. The detailed design for the new lead-lined hatch is shown in foreground over the red section of floor. The downstream wall of this new hatch abuts, but is not attached to the existing 12.3.1 hatch.

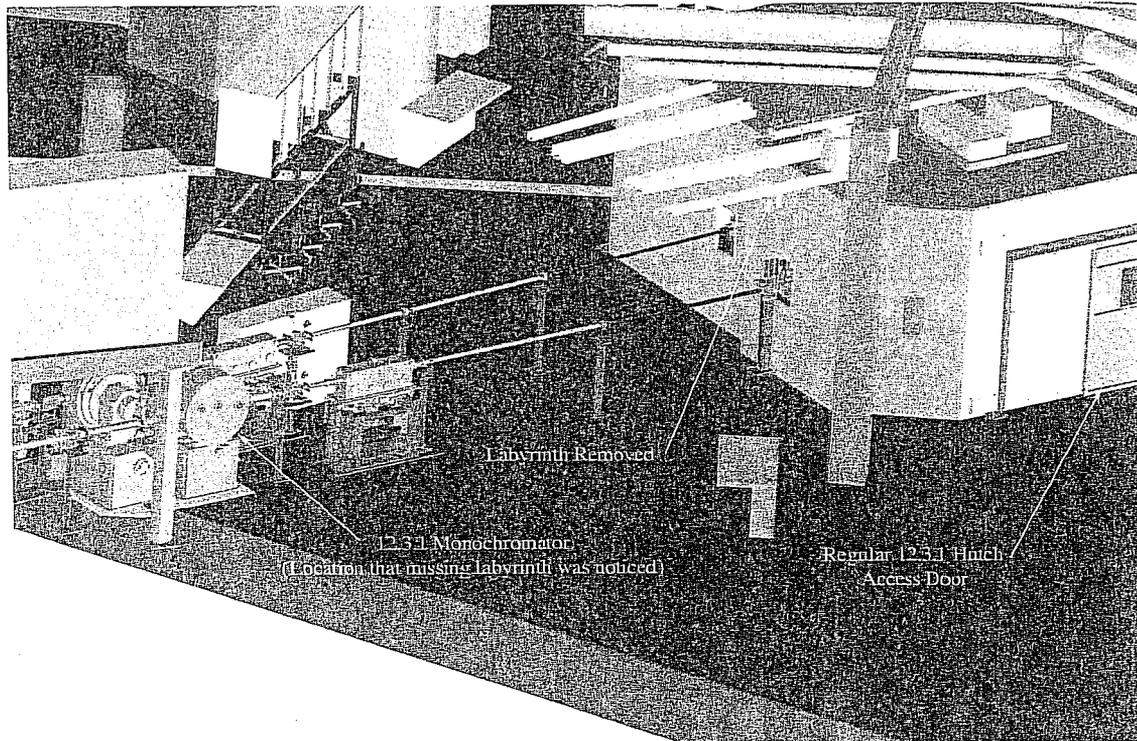
The engineer returned with the MT some minutes later and went to the 12.3.1 mono located upstream of both hutches (shown in the Figure 3) where they starting discussing what they would need to do for water flow adjustment. The engineer says they were just talking about when to call over the Beam Line Coordinator (BLC) to key off the beamline when the engineer looked towards his hutch and saw the bright interior lights coming out of the hole where the labyrinth was. The engineer realized that the labyrinth had been removed.

Figure 3. Layout of the 12.3.1 hutch, and the area where the 12.3.2 hutch was being installed (but no walls were yet in place as shown in the figure) upstream of the 12.3.1 hutch. The location of the 12.3.1 monochromator is noted as that is where the engineer was standing by when he noticed the missing labyrinth, also noted.

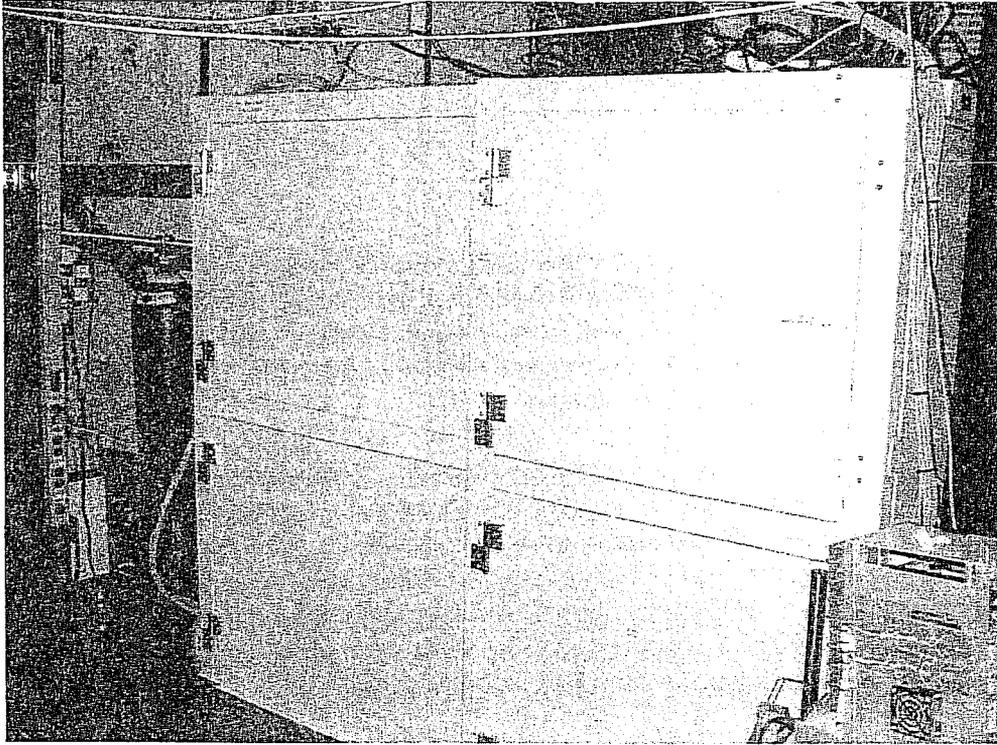
Figure 1. Side view of monochromator enclosure showing four hinged panels

Inside the mono vacuum chamber are seven servomotors that adjust tilt, yaw, twist, bend and displacement of the monochromator crystals. On Saturday, 15 Oct 05 at 3:05 pm, a building power-dip caused a motor encoder to lose “homing”. A move command was then sent to the motor that sent it beyond the range of allowable adjustment and a hard stop was hit. To get the device off of the hard stop, the mono chamber had to be opened and some of the hardware dismantled.

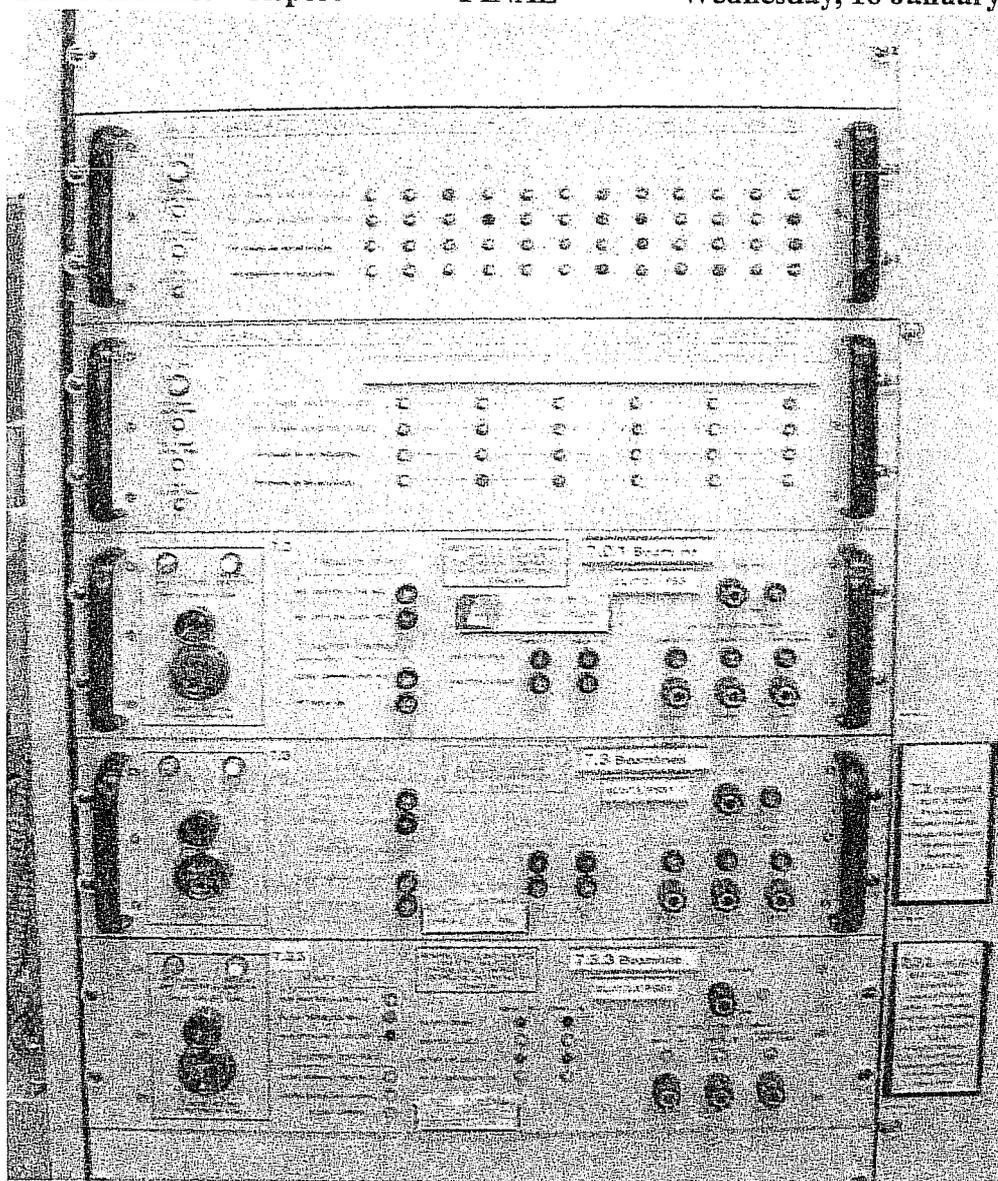
Figure 1: Front of beamline sector 7 RSS equipment. The top unit is the ring summation chassis with a column of 4 lights for each of the 12 sectors. The next unit down is the sector 7 summation chassis. An identical unit is located at each sector. Below this unit are the beamline 7.0.1, 7.3 and 7.3.3. RSS chassis. On the lefthand side of each of these three bottom units is a red cup for the Off-Line push button and below it the On-Line key switch lock-cylinder. The green lights above and to the right of the red cup indicates that these three beamlines are presently On-Line. The Off-Line indicator light is to the left of the green light and would it be red when the beamline is Off-Line and the green light would be extinguished.

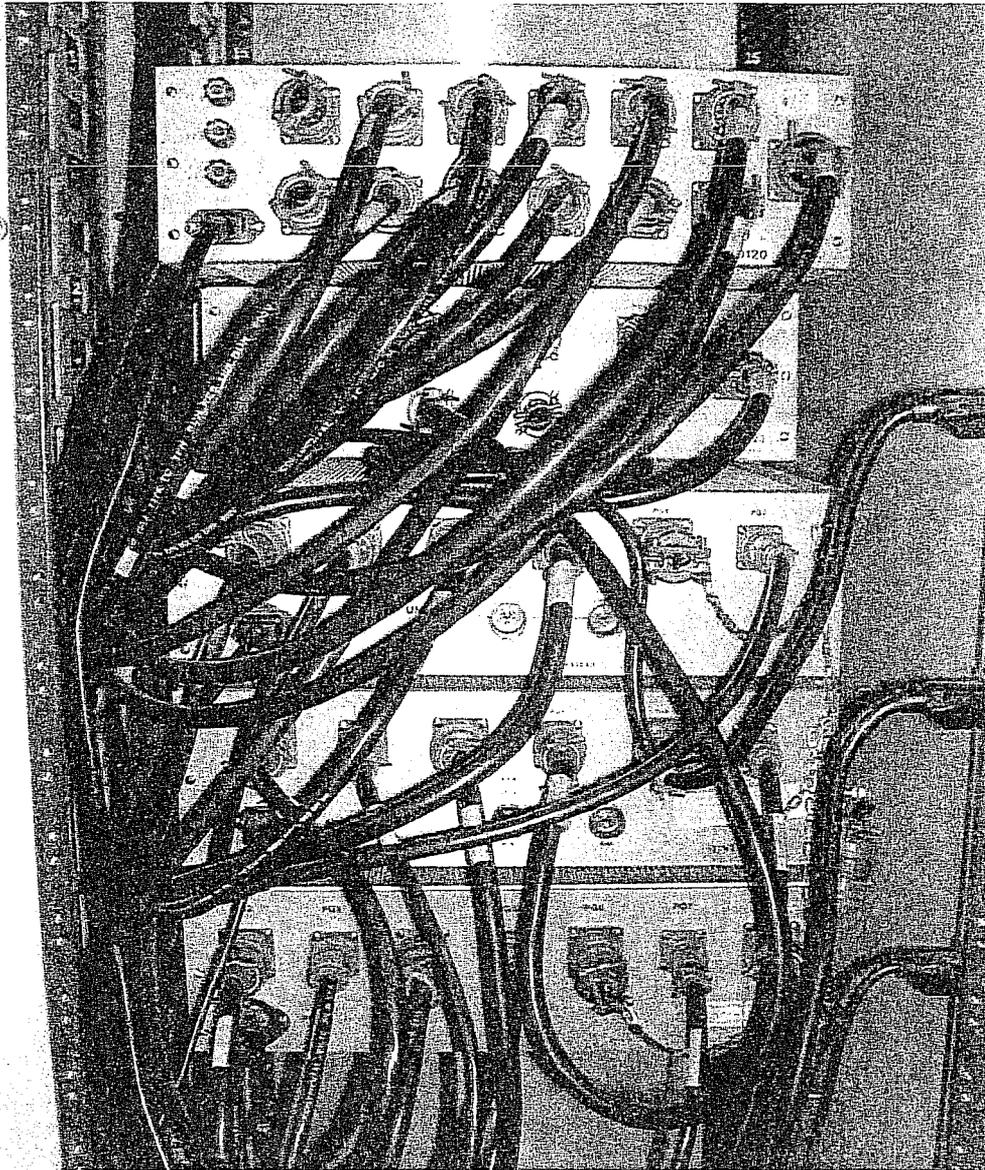
Figure 2: Picture of the rear of the sector 7 RSS equipment rack. The top unit is the ring summation chassis. The next unit down is the sector 7 summation chassis. An identical unit is located at each sector. Below this unit are the beamline 7.0.1, 7.3 and 7.3.3. RSS chassis. The test switches are located in the copper colored protective cups in the second and third units from the bottom. The bottom unit is an older chassis without test switches and requires disconnecting a cable and a test plug installed.

During this re-testing, EM1 observed *'everything dropping out back to sector 7'* at the ring summation chassis. This would have been a correct observation when a sector 7 beamline RSS chassis test switch was flipped. EM1 noticed the beamline 7.3 chassis was Off-Line, as it should be because of the BLC taking it Off-Line on December 23, 2005.
