*B. Townsend, M. Cerpak, M. Keenihan, M. Nelson, "DENR  
Underground Inspection Report", June 13, 2003*

## **HOMESTAKE UNDERGROUND INSPECTION**

**June 13, 2003**

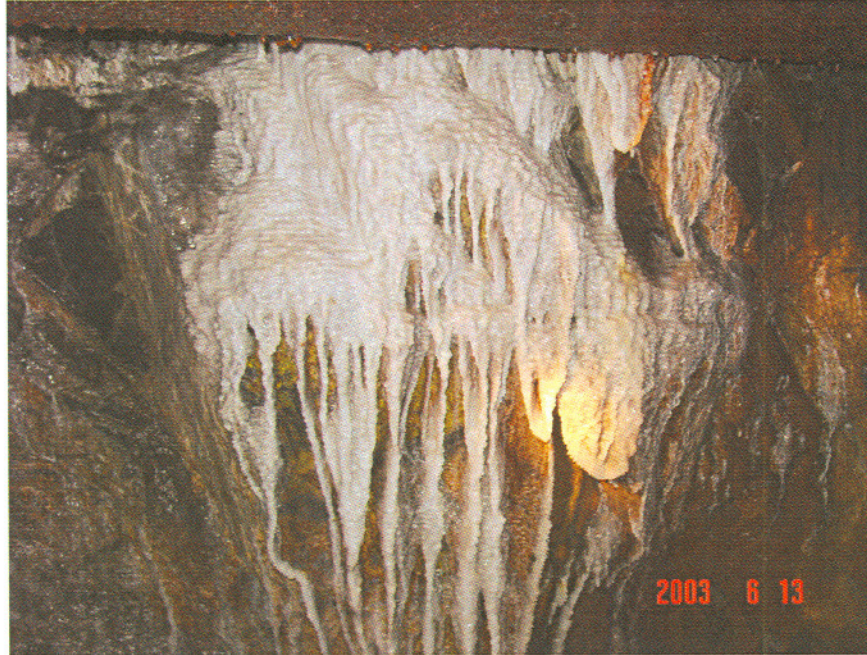
In locations where water was seeping into the 1700 level drift, secondary calcium carbonate stalactites were observed. It was noted that in Main Ledge, stalactites were present in wet areas, and that they decreased in abundance towards 7 and 9 Ledges. These features were not observed in other areas of the mine. The stalactites range from <1 inch to several inches in length. The mineral textures indicate that the stalactites formed in the drift since it was constructed. One area of calcium carbonate flowstone was observed and is shown in Figure 1, although this photo is not representative of the overall quantity of calcium carbonate in the drift. As calcium carbonate precipitates were extensive in some areas, the inspectors discussed with Homestake personnel the buffering capacity they may provide to counteract potential acid mine drainage. Homestake personnel also pointed out that ballast rock used for laying the railroad track in many of the mine areas consists of crushed limestone, adding additional potential buffering capacity.

Photo 1. 1700 Level, Main Ledge, calcium carbonate flow stone.

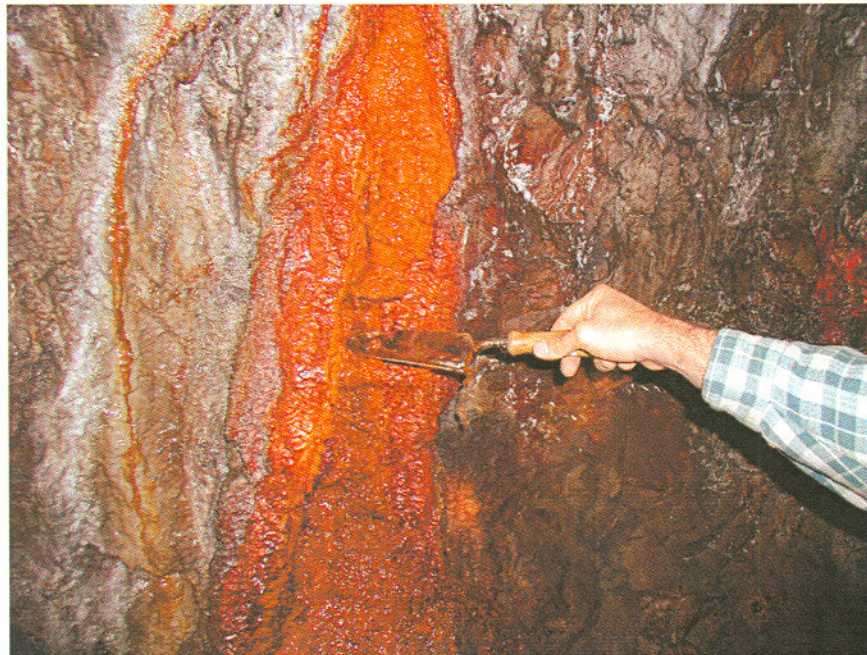
In Main Ledge near the Ellison Shaft, after the Yates “Y”, water in the drift was field tested and had a pH of 7.1, temperature of 10.8 degrees C, and an electrical conductivity of over 2000 uS/cm. A sample of red iron hydroxide precipitate was taken in this area. Iron hydroxide precipitates may sequester arsenic and other potential contaminants in a form which can re-dissolve based on the oxidation-reduction potential and pH of the water. As these conditions will change once mine ventilation ceases, the precipitates are a potential contaminant source. Additional evaluation is in progress. The field paste pH of the precipitate was 7.4.

Photo 2. 1700 Level, Main Ledge, near Ellison, red precipitate.

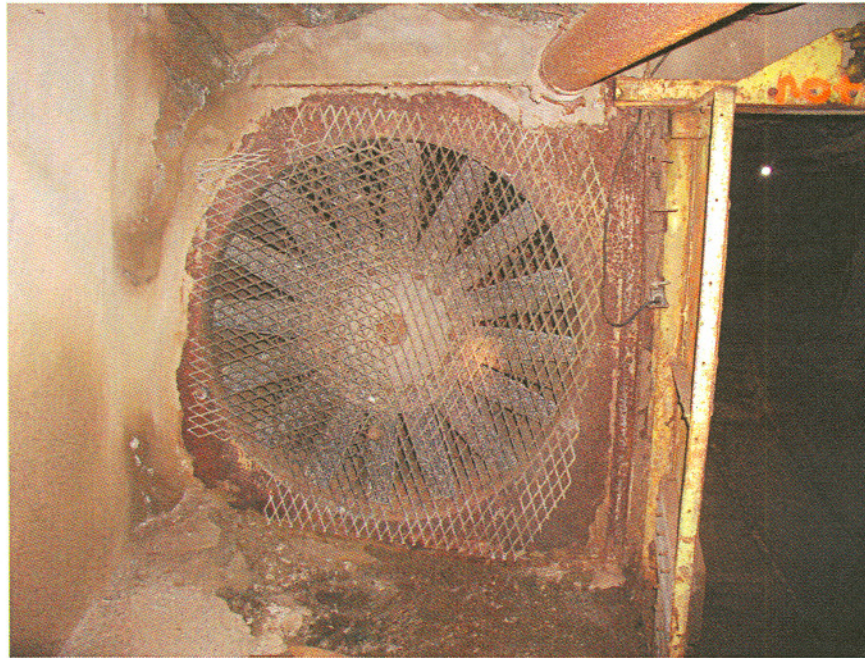
Abandoned infrastructure observed in these areas consisted primarily of narrow-gauge railroad tracks and ties, air lines, and water lines. The inspectors also noted electrical junction boxes, air-handling equipment, wood stoping, sand pumping equipment, empty explosive storage areas, dry transformer pads, and rock chutes abandoned in these areas. The inspectors observed a large 125 HP, four-foot diameter ventilation booster fan abandoned in place in the Ellison S-Curves area, and noted this fan still turned freely on its bearings. Homestake personnel said this fan had sealed bearings that contained minimal quantities of lubricant.

Photo 3. 1700 Level, near Ellison S-Curves, 125 HP booster fan abandoned in place.

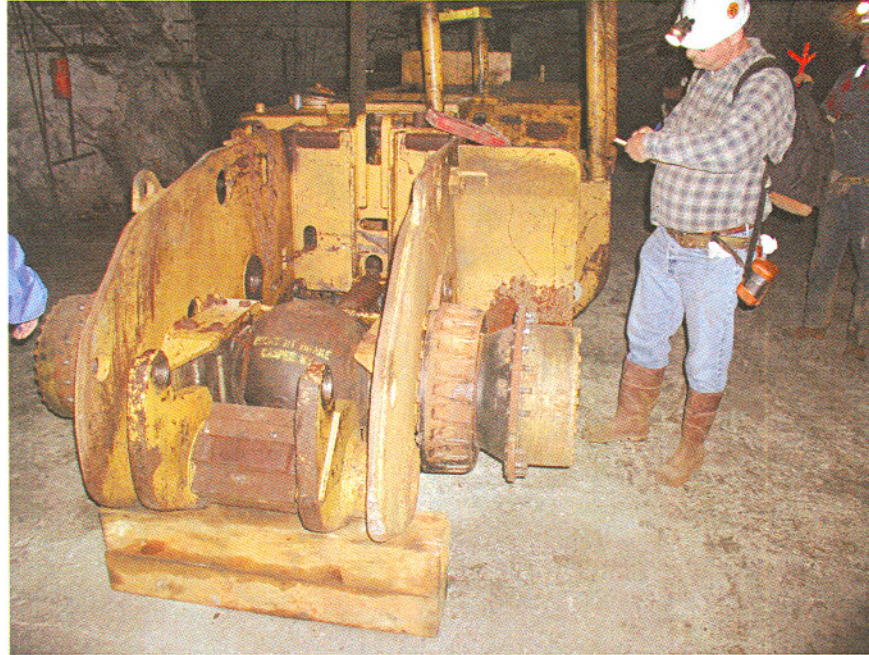
1700 Level, 7 Ledge Load-Haul-Dump (LHD) Shop. The inspectors noted Homestake had thoroughly cleaned this shop area during closure work. Homestake personnel reported they removed oils and solvents from the shop area, steam-cleaned the shop floor, applied absorbent to the floor, and then swept the absorbent up to remove any remaining residues. There was not a holding tank floor sump in this shop area. Homestake had removed most materials from this shop area, and the remaining materials were primarily pieces of fabricated steel. The inspectors noted Homestake abandoned a three yard Wagner LHD chassis in this shop area. Observations verified Homestake personnel had removed the engine, transmission, hydraulic hoses, radiator, and other components that typically contained fluids. The hydraulic oil reservoir was empty and had absorbent placed inside the reservoir. The inspectors were also able to verify oil had been removed from the axle and the drain plug was left open. No oil residue had accumulated below the removed plug, indicating company personnel had done a thorough job of removing the oil.

Photo 4. 1700 Level, 7 Ledge LHD shop, 3-yard Wagner LHD chassis abandoned in place.

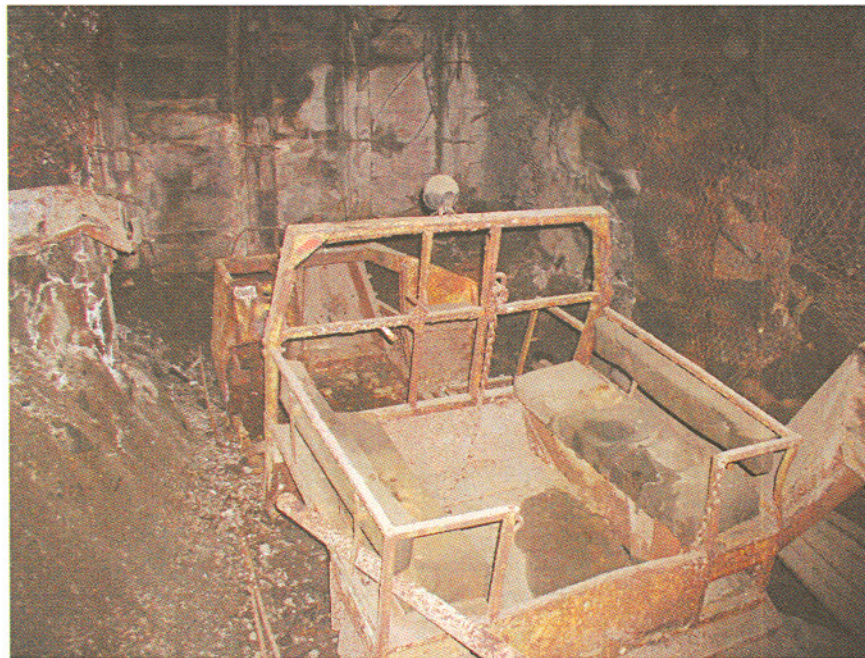
Photo 5. 1700 Level, 7 Ledge LHD shop, “Boss Buggy” chassis abandoned in place.

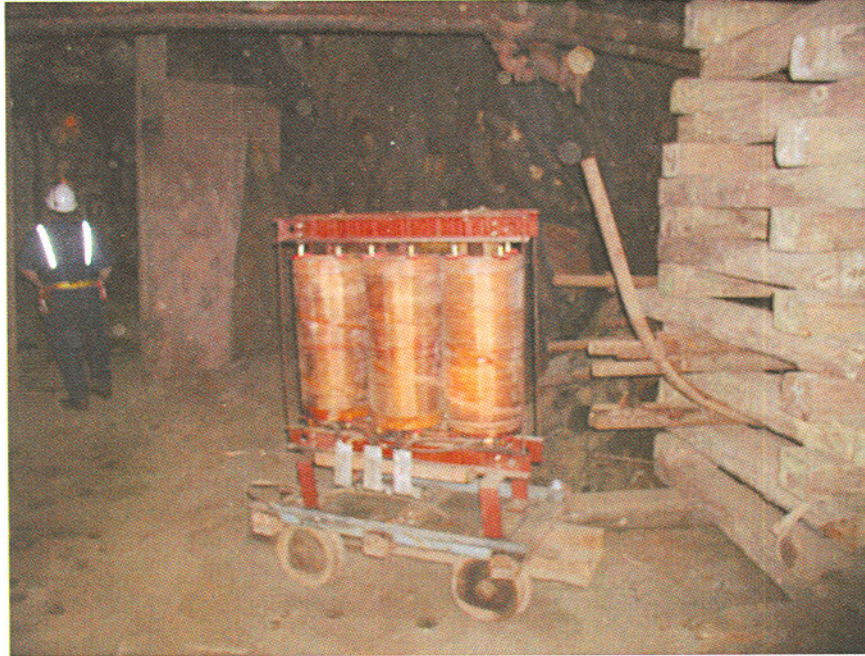
Photo 6. 1700 Level, 7 Ledge shop area, dry core transformer abandoned in place. Note cribbing for roof support.

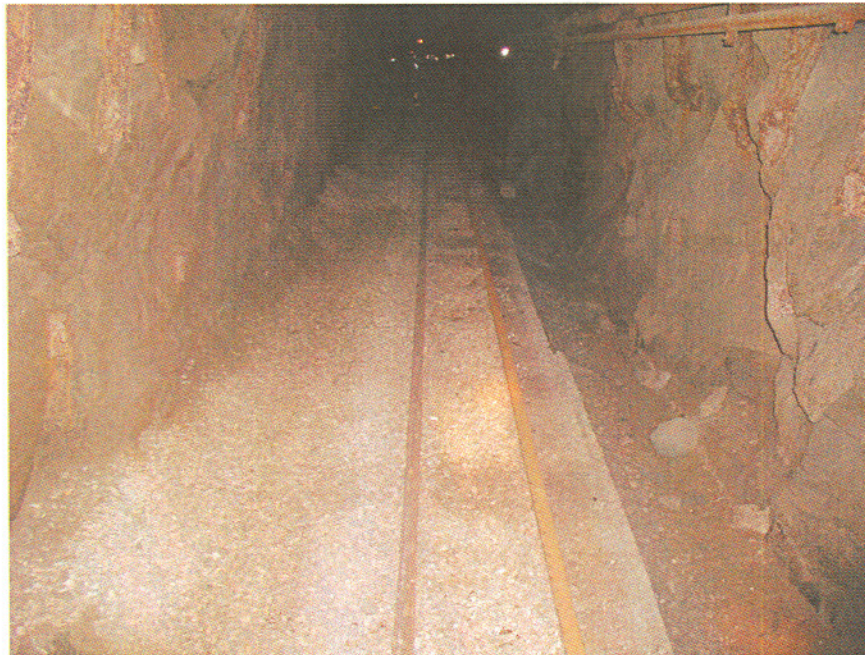
Photo 7. 2000 Level, 9 Ledge drift, limestone track ballast.

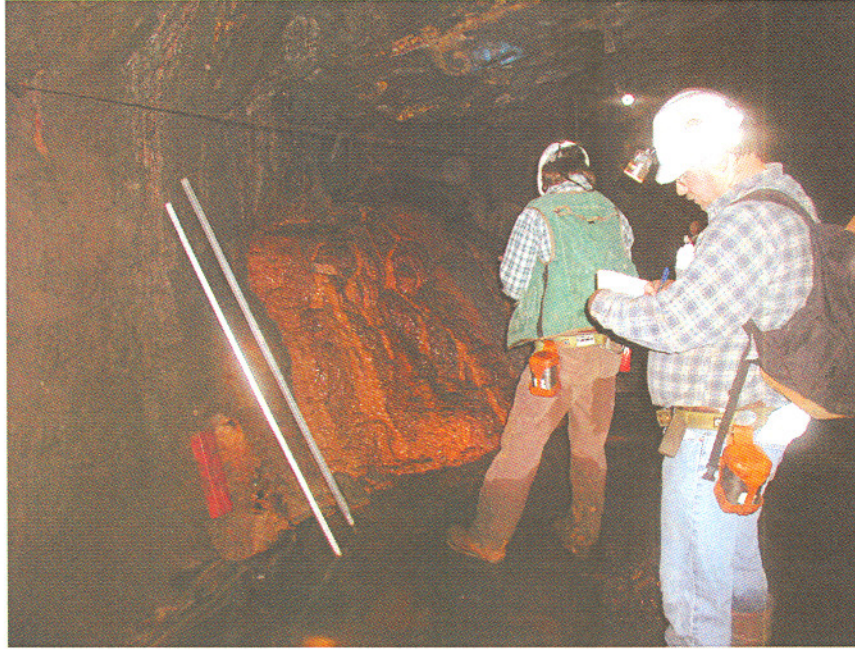
2 Crosscut South 9 Ledge 3800 Level Backfilled Drift. In the drift on the way to the shop areas, we observed a backfilled stope that had water running from it. There was a large accumulation of iron hydroxide precipitates in the area where the water entered the drift (photo 8). Homestake personnel said this backfilled drift was the location where a fire started in a backfilled timber stope that they flooded to extinguish the fire. The inspectors collected a sample of water and precipitates at this location.

A field parameters of the water indicated a pH of 6.6, temperature of 25.9 degrees C, and an electrical conductivity of over 2000 uS/cm. The laboratory analysis indicates that water had very high TDS and sulfate concentrations similar to previous water samples that had interacted with mine rock. As a result of low flow rates and the large accumulation of iron hydroxide precipitates, the water sample contained a large quantity of suspended solids estimated at 2.4%. The total digestion of this sample (including the suspended solids) resulted in an extremely high arsenic concentration of 8.128 mg/l and a mercury concentration of 0.004 mg/l. Arsenic in the dissolved fraction of the sample was much lower and in the range previously observed in mine waters. This suggests that the precipitates contain both arsenic and mercury that had migrated from the backfilled timber stope and had coprecipitated or adsorbed to iron hydroxide forming in the oxidizing conditions of the ventilated drift. A solid sample of the precipitates was also collected and will be analyzed to test this hypothesis.

Photo 8. Iron hydroxide precipitates present where water was draining from flooded timber stope.

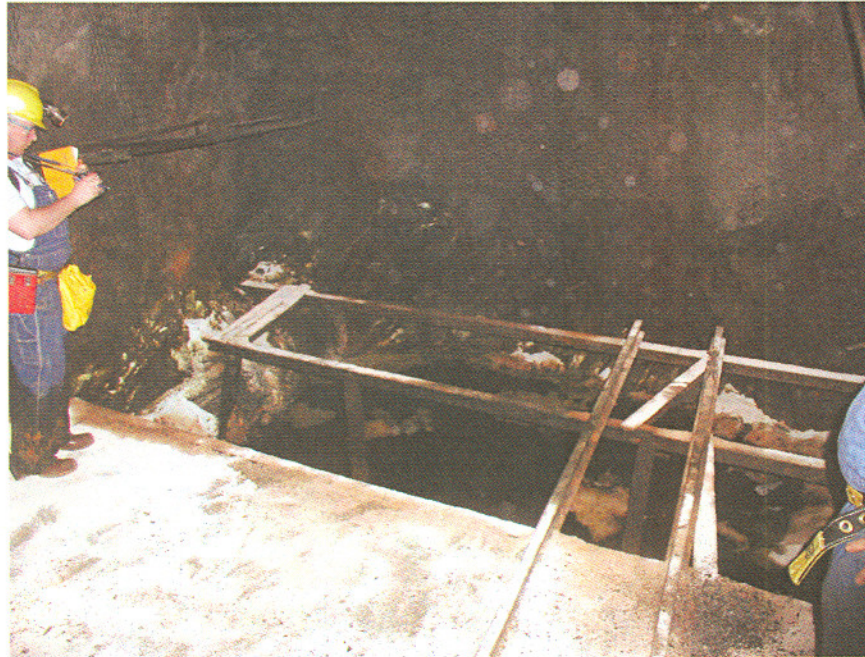
3800 Level Motorbarn and Fuel Storage Area. After walking through the areas noted above, we arrived at the 3800 Level motorbarn and fuel storage area. All the tires in a tire storage area had been removed. Storage bins and racks were still in place. The inspectors noted this FSA had water accumulating on the floor and this water had a visible sheen on the surface. Homestake personnel said they had cleaned this area twice previously, the initial closure cleaning and an additional cleaning when they noted a sheen similar to the one we observed. Homestake personnel said they would return and clean this area again because of the observed sheen. The inspectors did not collect a sample from this area because the presence of Spill Shark absorbent in this area would preclude laboratory testing for petroleum hydrocarbons, as noted during lab testing of a FSA sample collected during the May 28 inspection. The inspectors noted that, with the exception of the visible sheen on the water surface, the condition of this area appeared consistent with the final closure condition of the other fuel storage areas observed. The inspectors noted a slightly stronger petroleum odor in this area compared to previous locations.

Photo 9. 3800 Level Fuel Storage area. Note Spill Shark absorbent has been liberally applied.

During the June 13 underground inspection, DENR personnel noted the presence of a sheen on water accumulating in the 3800 Level Fuel Storage Area. Homestake personnel said they cleaned this area again after the initial closure cleaning because they noted a sheen similar to the one the inspectors observed. Homestake personnel said they would return to clean this area again because of the observed sheen. The inspectors surmise this recontamination occurs because small quantities of petroleum product present in small fractures in the floor of the fuel storage area continue to slowly emerge from the fractures. Therefore, it is possible other fuel storage areas will yield a similar condition when the mine begins to flood. However, the inspectors noted the minimal quantity of sheen present did not appear to indicate the presence of significant quantities of petroleum product and the inspection observations indicated Homestake had done a thorough job in cleaning these areas during closure work.

At 1:10 p.m. MDT, the inspectors held a closeout meeting with Homestake personnel. In addition to Burke, Mitchell and Regan, Todd Duex and Matt Zietlow also attended. Homestake personnel said they would return to the 3800 Level FSA to conduct additional closure work because of the sheen observed on the water surface. The inspectors and Homestake personnel discussed the closure work observed, and the inspectors noted the quality of the closure work appeared adequate and was consistent with the areas inspected on May 28 and June 6. We left the site at 1:45 p.m. MDT.

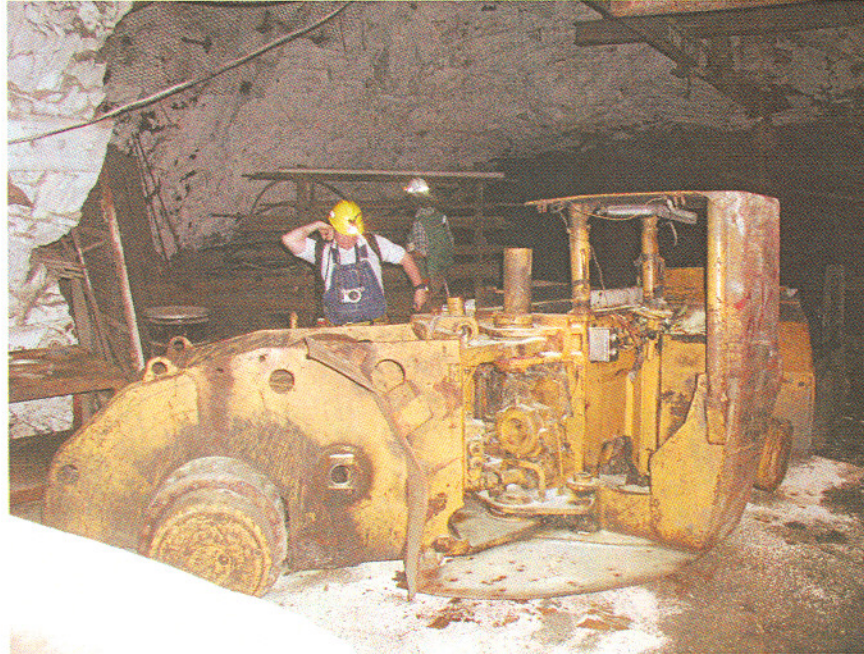
4100 Level LHD Shop. This shop was near the old 2 – 8D II Ledge 4100 mechanized cut and fill stope. The inspectors noted Homestake had thoroughly cleaned this shop area during closure work. There was not a holding tank floor sump in the shop area. Homestake had removed most materials from this shop area, and the remaining materials were primarily pieces of fabricated steel. The inspectors noted Homestake abandoned a three yard Wagner LHD chassis in the shop area. Observations verified Homestake personnel had removed the engine, transmission, hydraulic hoses, radiator, and other components that typically contained fluids. The hydraulic oil reservoir was empty and absorbent had been placed inside the reservoir.

Photo 9. 4100 11 Ledge LHD Shop. Three yard LHD chassis abandoned in place.
