**Subject: Lawrence Berkeley National Laboratory Stormwater Annual Report for 2013-2014,
Waste Discharge Identification Number 2 011002421**

Stormwater Annual Report for 2013-2014

Prepared by:
Lawrence Berkeley National Laboratory
Environmental Services Group
WDID 2 01 I002421

June 2014

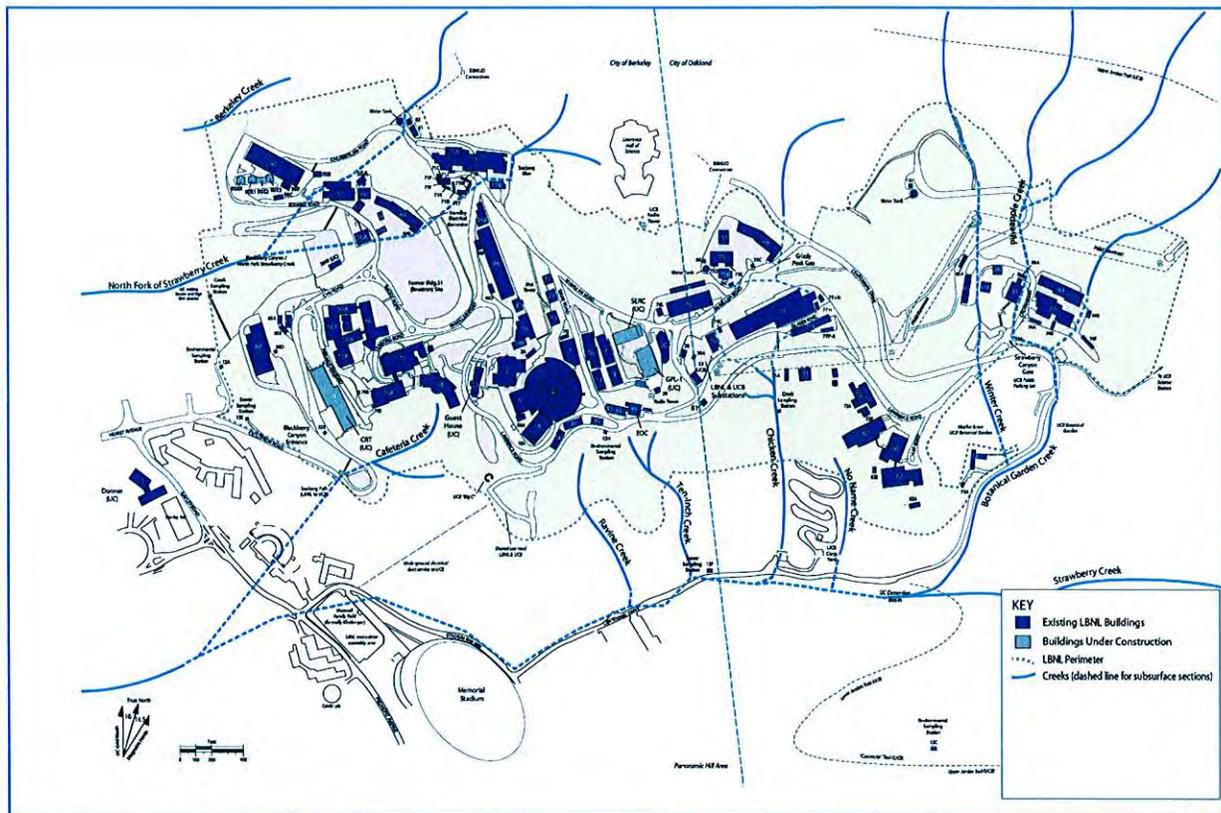
Figure 2-1 Facility Map

Berkeley Lab is a member of the national laboratory system supported by the U.S. Department of Energy through its Office of Science. It is managed by the University of California (UC) and conducts unclassified research across a wide range of scientific disciplines. The facility occupies approximately 200 acres within the Cities of Berkeley and Oakland, both of which are located in Alameda County. Roughly one-half of the site is within Strawberry Canyon and has a south-facing orientation; the balance is within Blackberry Canyon and is oriented toward the west. Approximately 80 permanent buildings and approximately 100 trailers and temporary structures are located at the facility. About 110 acres are undeveloped with vegetated steep slopes. A facility map with major buildings and surrounding creeks is shown on Figure 2-1.

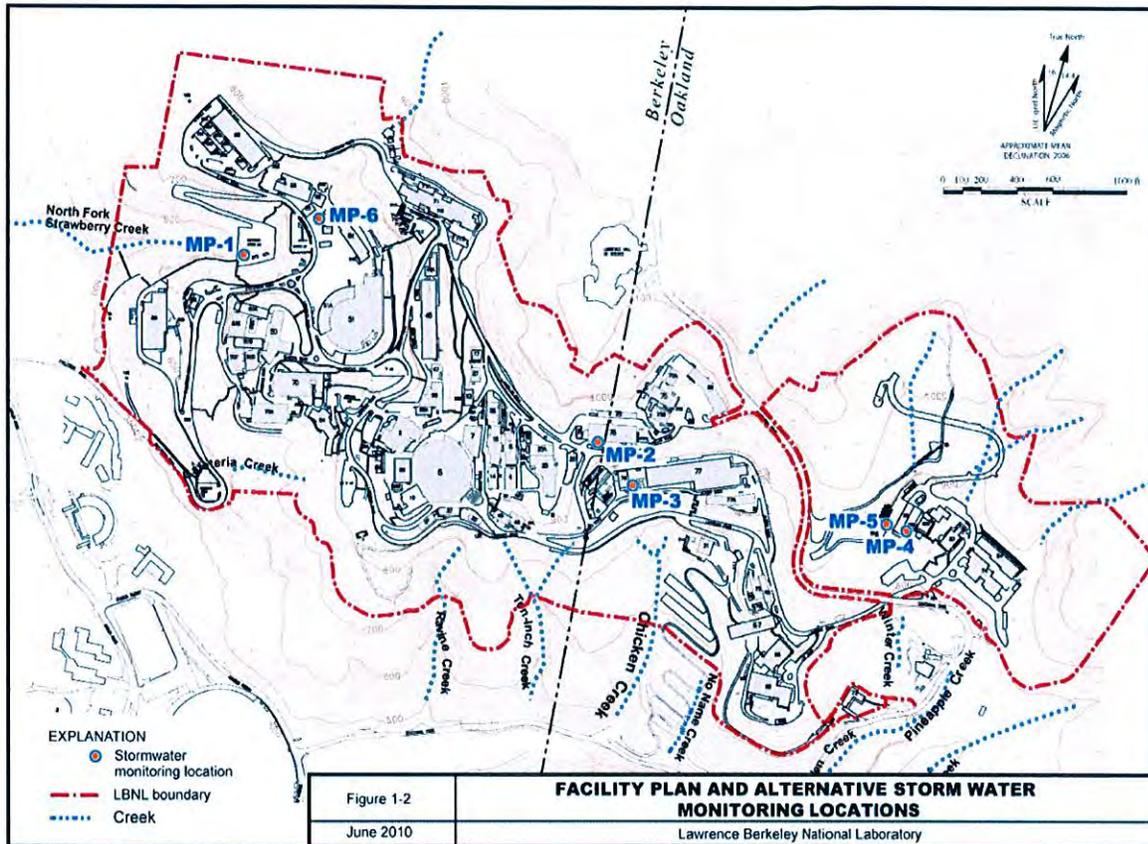
Figure 3-1 Monitoring Locations

1. MP-1: Blackberry Parking Lot
2. MP-2: Building 76 Vehicle Fueling Station
3. MP-3: Building 77/79 Metal Fabrication, Storage and Scrap Recycling Area
4. MP-4: Building 85 Hazardous Waste Handling Facility, Upper Yard
5. MP-5: Building 85 Hazardous Waste Handling Facility, Lower Yard
6. MP-6: Building 64 Bus Parking Lot

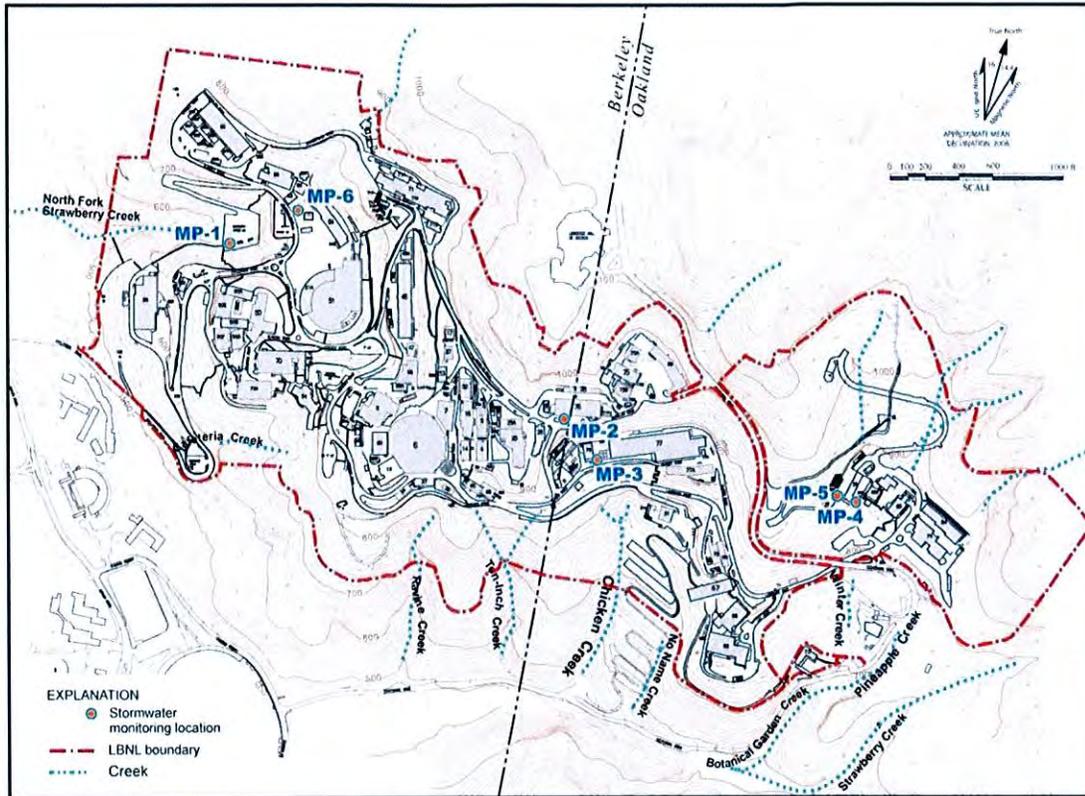
Figure 1. LBNL Facility Plan with Buildings, Topography, and Stormwater Monitoring Locations

The ASWMP was prepared to provide a more industrial activity-specific indicator of pollutant contributions from regulated industrial activities at LBNL and thus a more reliable basis for evaluating the performance and effectiveness of Best Management Practices (BMPs) as described in the *Stormwater Pollution Prevention Plan* for the Facility (SWPPP; ESG, 2009). The specific industrial sites targeted in the ASWMP are shown on the following Figure 1 and include:

1. Storage at the Blackberry Canyon parking lot (stormwater sample location MP-1);
2. Fueling area at Building 76 (stormwater sample location MP-2);
3. Metal fabrication, storage, and recycling at Building 77 and 79 (stormwater sample location MP-3);
4. Hazardous waste storage and handling at Building 85 (stormwater sample locations MP-4 and MP-5);
and,
5. Bus transportation and parking in front of Building 64 (stormwater sample location MP-6).

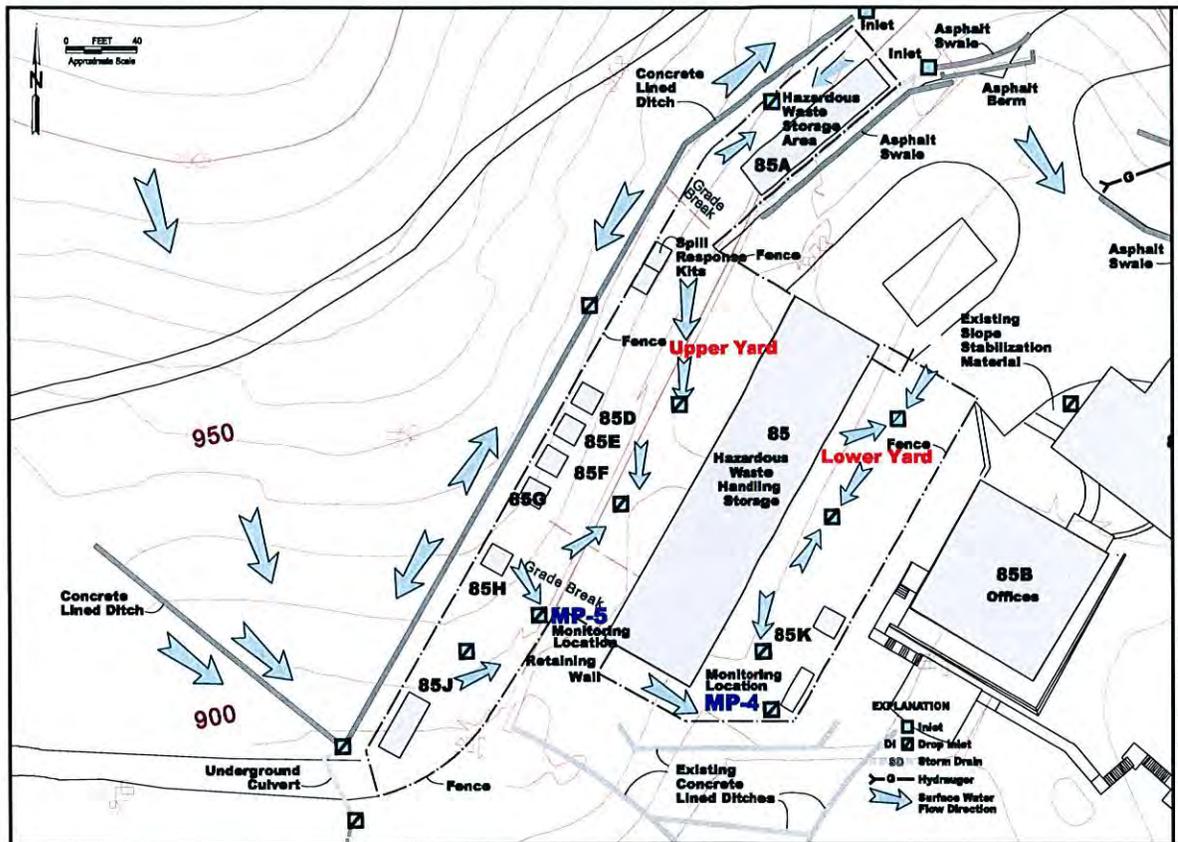
Figure 2. Schematic Overview of the Hazardous Waste Handling Facility, Building 85

During the 2009/2010 storm season, stormwater samples MP-4 and MP-5 collected at the hazardous waste storage and handling area (Building 85 or B85) exceeded the bench mark values included in the ASWMP for chemical oxygen demand (COD) and Magnesium (Mg). In response, LBNL conducted an investigative study to identify the potential sources of these constituents in the B85 upper and lower yard. The 2009/2010 stormwater sample results are summarized in Table 1 along with the ASWMP benchmarks for these constituents. A schematic overview for the B85 area is shown on [Figure 2](#).

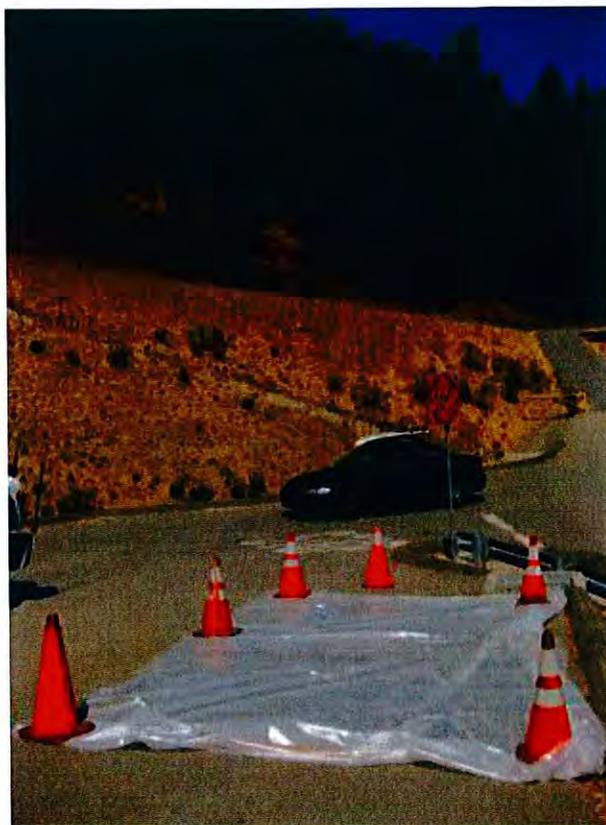
Photo 1. Deployed plastic at the upper water tower

LBNL collected an equipment blank to assure the pre-cleaned, acid-washed sampling equipment was not contributing COD or Mg to the samples.

The Repeat Aerial Deposition study (October) was very similar in procedural setup to the September Aerial Deposition study. The Repeat Aerial Deposition study differs in the following aspects:
