Lawrence Berkeley
National Laboratory

Stormwater Annual Report for 2014-2015

Prepared by:
Lawrence Berkeley National Laboratory
Environment/Safety/Health Division
Environmental Services Group
WDID 2 01 I002421

June 2015

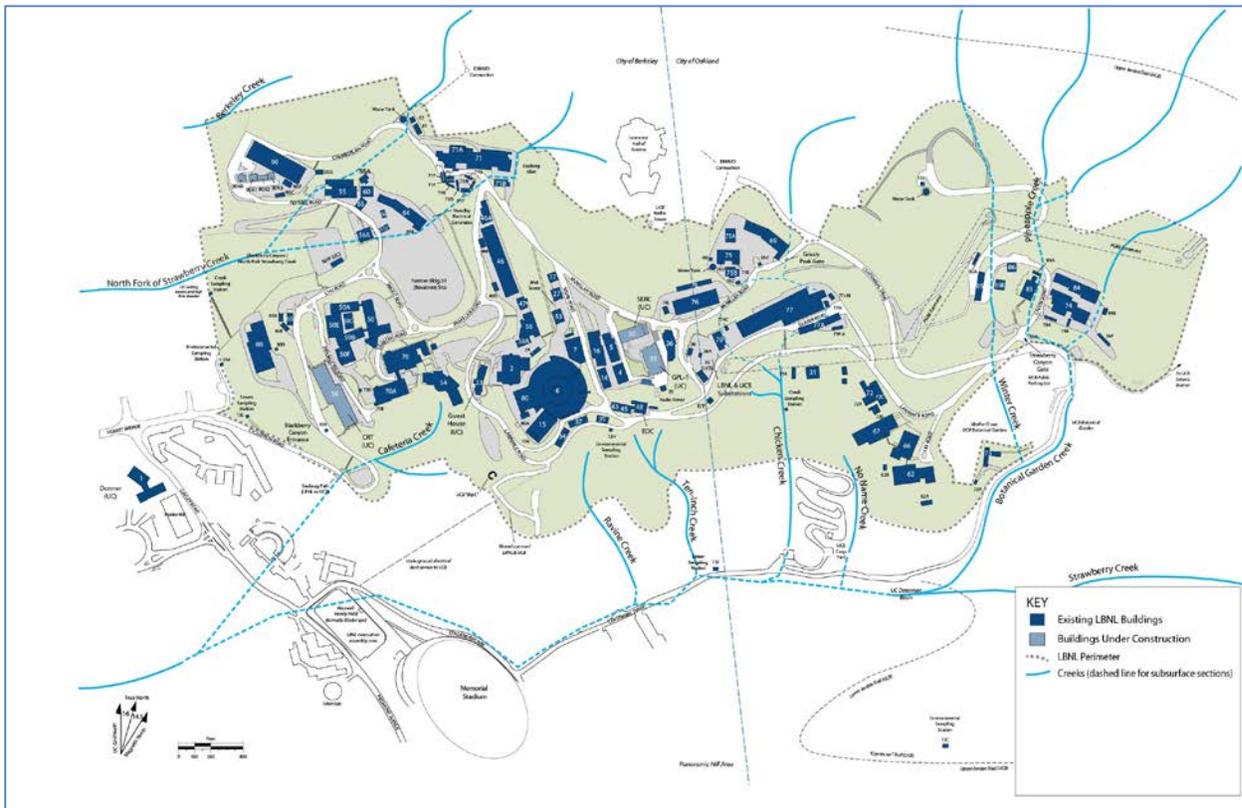
Figure 2-1 Facility Map

Berkeley Lab is a member of the national laboratory system supported by the U.S. Department of Energy through its Office of Science. It is managed by the University of California (UC) and conducts unclassified research across a wide range of scientific disciplines. The facility occupies approximately 200 acres within the Cities of Berkeley and Oakland, both of which are located in Alameda County. Roughly one-half of the site is within Strawberry Canyon and has a south-facing orientation; the balance is within Blackberry Canyon and is oriented toward the west. Approximately 80 permanent buildings and 100 trailers and temporary structures are located at the facility. On the order of 110 acres are undeveloped with vegetated steep slopes. A facility map with major buildings and surrounding creeks is shown on Figure 2-1.

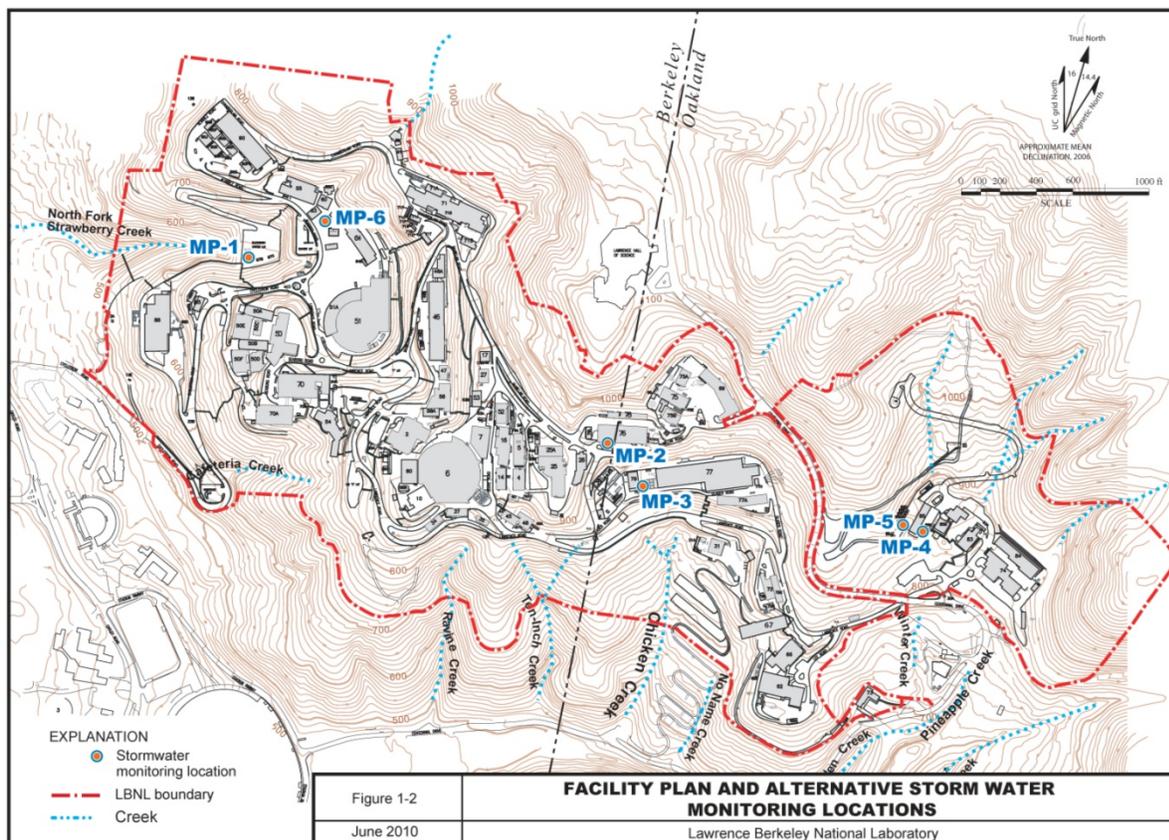
Figure 3-1 Monitoring Locations

MP-4: Building 85 Hazardous Waste Handling Facility, Upper Yard

MP-5: Building 85 Hazardous Waste Handling Facility, Lower Yard

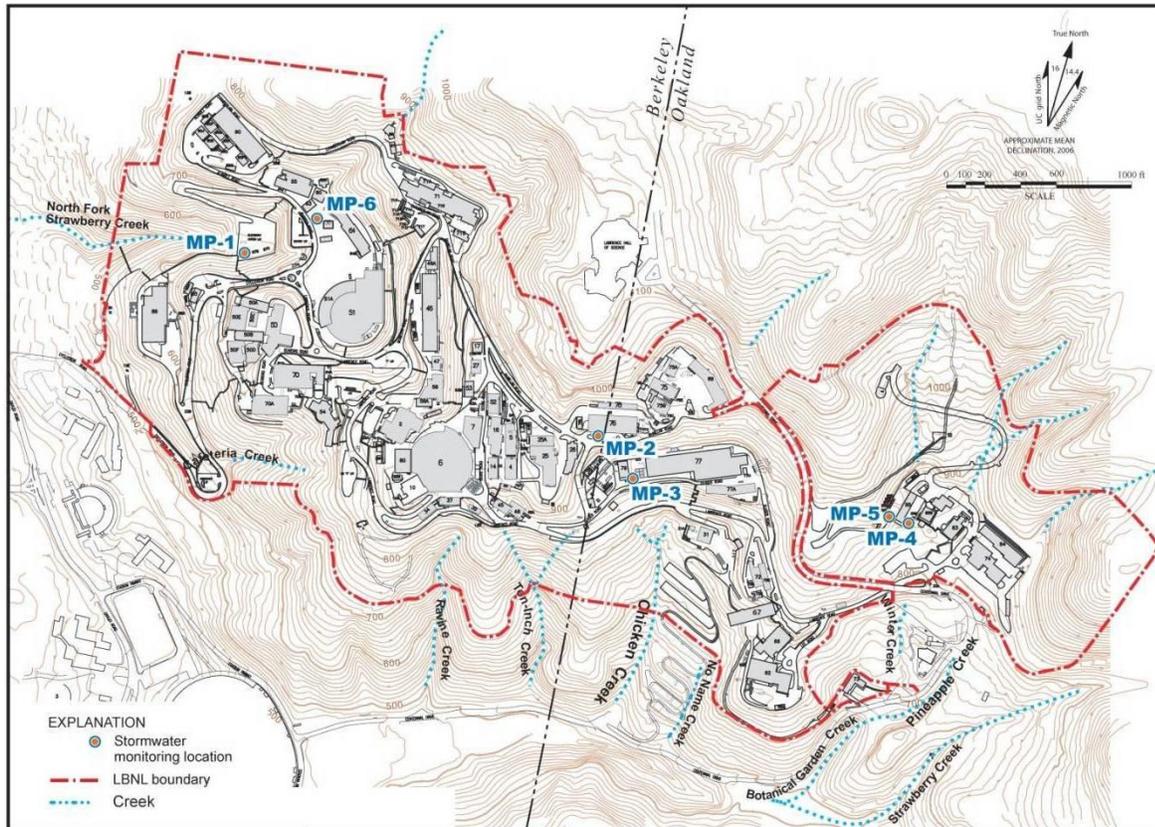
Storm Event Sampling and Analysis

The ASWMP was prepared to provide a more industrial activity-specific indicator of pollutant contributions from regulated industrial activities at LBNL and thus a more reliable basis for evaluating the performance and effectiveness of Best Management Practices (BMPs) as described in the *Stormwater Pollution Prevention Plan* for the Facility (SWPPP; ESG, 2009). The specific industrial sites targeted in the ASWMP are shown on the following Figure 1 and include:

1. Storage at the Blackberry Canyon parking lot (stormwater sample location MP-1);
2. Fueling area at Building 76 (stormwater sample location MP-2);
3. Metal fabrication, storage, and recycling at Building 77 and 79 (stormwater sample location MP-3);
4. Hazardous waste storage and handling at Building 85 (stormwater sample locations MP-4 and MP-5); and,
5. Bus transportation and parking in front of Building 64 (stormwater sample location MP-6).

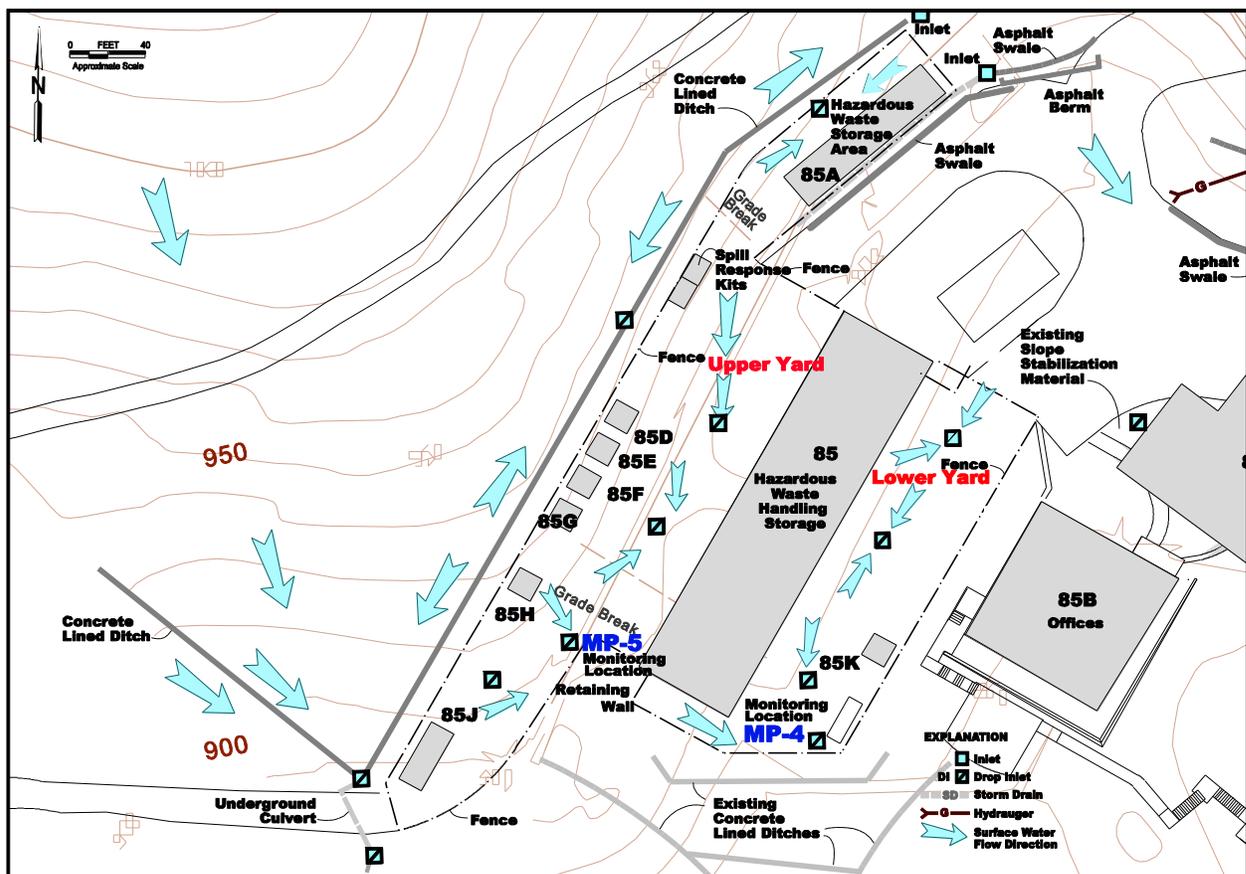
- Runoff occurred during normal business operating hours;
- The sample was collected within the first hour of discharge from the site; and
- Rainfall had not been measured at the facility within three working days prior to the sampling event.

During the 2009/2010 storm season, stormwater samples MP-4 and MP-5 collected at the hazardous waste storage and handling area (Building 85 or B85) exceeded the bench mark values included in the ASWMP for chemical oxygen demand (COD) and Magnesium (Mg). In response, LBNL conducted an investigative study to identify the potential sources of these constituents in the B85 upper and lower yard. The 2009/2010 stormwater sample results are summarized in Table 1 along with the ASWMP benchmarks for these constituents. A schematic overview for the B85 area is shown on [Figure 2](#).

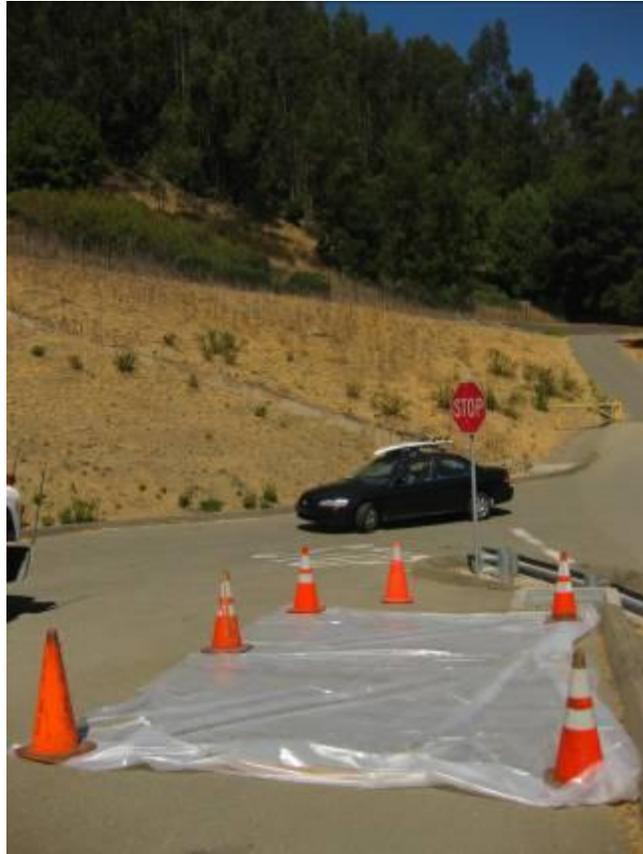
Visual Observations of Non-Stormwater and Stormwater Discharges

4.1 Observations of Authorized Non-Stormwater Discharges
