Take Care When Selecting Laser Eyewear

Wear Your Laser Eye-wear!

Safety Gate Valve Improperly Locked Out/Tagged

Use of Incorrect Eyewear Leads to Laser Eye Exposure

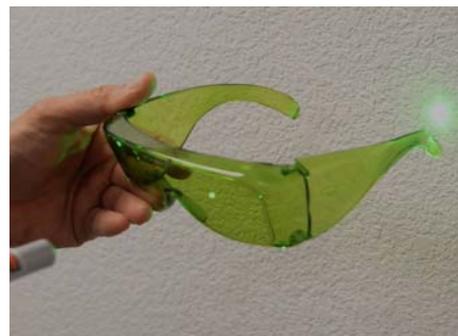
Upon further investigation, it was discovered that the LPE the laser operator was wearing did not afford protection for the 400 nm wavelength, just the 800 nm. The incident was immediately reported to management and the laser operator was taken to Medical for evaluation, where he received a referral to an ophthalmologist for further evaluation. The ophthalmologist's evaluation indicated that the laser operator did not have any injury to the eye as a result of exposure to the beam.

Figure 1. Wrong eyewear transparent to laser beam

REMEMBER that LPE is your Last Line of Defense. Don't take your eyesight for granted. Know what you are wearing and BE SAFE!

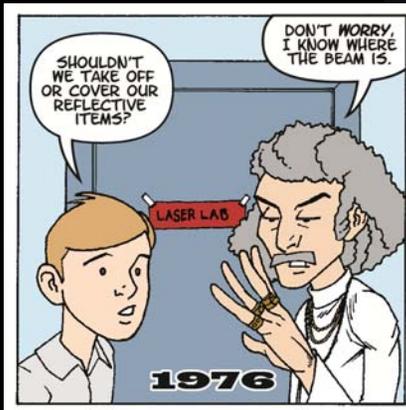
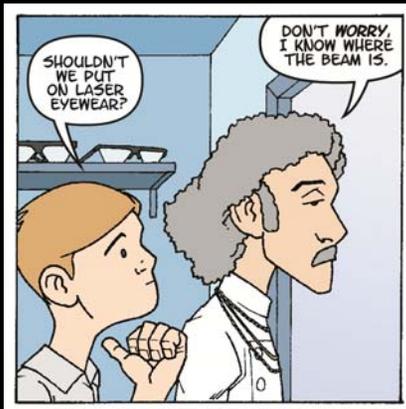
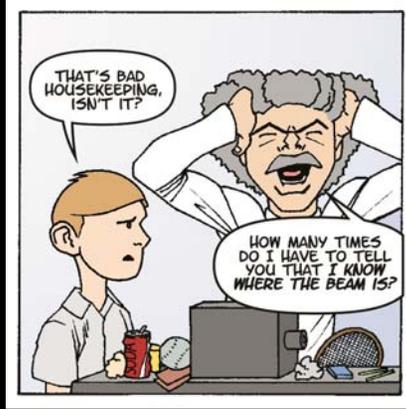
The operator quickly replaced the LPE and, using an infrared viewer, located a stray laser beam being reflected from the inactive experiment on the opposite end of the optical table. The beam was being reflected off the opaque piece of laser enclosure material. The laser enclosure panel, not normally used as a temporary beam stop, was positioned at an inclined angle and consequently reflected the beam at an upward angle toward the primary work area where the operator had been standing on the step ladder. (See Figure 4)

- Insufficient communication between users of a shared laser beam.
- Second beam was active when not in use.
- Selection of inappropriate material (reflective surface, susceptible to laser damage) and position for the beam block.
- Operator of the second set-up had not verified safe conditions (blocking of stray reflections) after modifying the setup (changing/blocking the beam path).
- Limited illumination impaired visibility of the instrumentation readings.

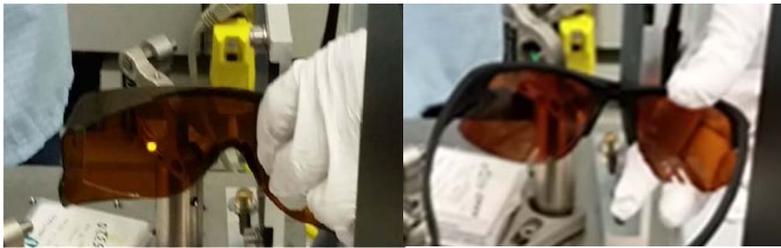
On July 18, 2016 a worker at a DOE Lab was aligning a pulsed green laser (527nm) to a semiconductor wafer when a reflection was directed off the face of the wafer toward the worker's LPE. The worker described the laser beam interaction with the LPE as bright flashes of light across the upper part of the eyewear. The worker was concerned because what he saw (bright flashes) was similar to what is reported by those involved in laser eye injuries. Management was notified and the worker was directed to get an eye examination. No damage was found.

Believing that the LPE may be defective, tests were performed on the eyewear and it was found to be working as designed. The

Figure 7. Fluorescing spot on left pair while right pair shows no effect

eyewear did brightly fluoresce when struck by a green laser beam (See Figure 7). Other eyewear in the lab was tested, and only the YAG/KTP filter was found to produce the fluorescing phenomenon when struck. The rest produced only a dull spot on the inside of the eyewear during the same test. Further testing found other filters by different manufacturers resulted in the same fluorescence. Be aware when using filters used to block visible laser beams, there will be some reemission of light if struck by a laser beam.

Takeaways from this incident were that we must always practice good beam control when performing laser alignments:

1. Reduce laser output energy/power to as low as practical to perform the alignment. (Viewing cards are not meant for imprinting a burn pattern upon and neither are your eyes.)
2. Do not move optics into or out of the beam path with laser(s) on.
3. Ensure downstream beam is blocked while performing course adjustments.
4. When using viewing cards, direct them down toward the table and not upward.
5. Use cameras when possible to free up your hands.
