Volume 4
Issue 2

Laser Lessons News Letter

The Last Line of Defense - correct and properly fitted laser protective eyewear

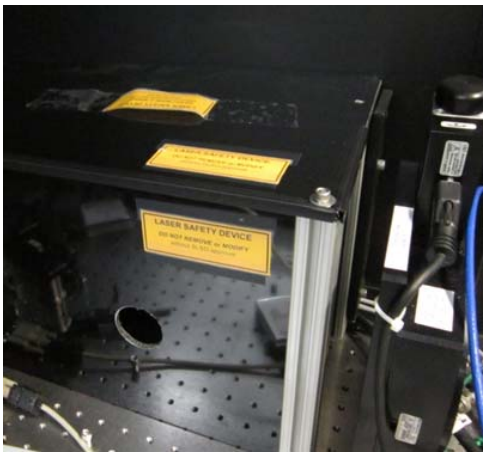
Figure 4: Shutter enclosure for the dual Exit Shutters

The user's alignment laser work was with the area in Laser Off Mode. The user wanted to transport the laser beam from the end station back through an optics path inside the table enclosure that would later be used for the high power beam, but was prevented from doing this by the dual Exit Shutters. These shutters are located inside a shutter enclosure, shown in Figure 4, that is inside the large table enclosure.

The Exit Shutters and the associated shutter enclosure are secured and affixed with labels stating, "Laser Safety Device – Do Not Remove or Modify without SLSO Approval." SLSO is an acronym for the System Laser Safety Officer. To perform the desired work, the user should have consulted with the SLSO, who would have arranged for this to be done with the area in the Laser Off – Alignment mode. However, the user did not do this! Because the Hutch was in Laser Off mode, the user did not consider it would be unsafe to remove the shutter enclosure panel and prop open the 2 Exit Shutters. The user acknowledged reading the safety labels but did not perceive these actions as unsafe because of the Laser Off operation mode. When the user lifted the shutter blade, the engineered laser safety system generated a "shutter inconsistent state" interlock fault and sounded an audible alarm. This resulted in notification to an area manager and the SLSO, who subsequently found that a laser safety barrier had been modified without proper authorization.

Lab management for the DOE facility investigated the incident and determined the unauthorized modification of the laser safety shutter/enclosure to be a significant event, and submitted a notification to DOE's ORPS reporting system. Corrective actions taken included: verification that the Exit Shutters and associated shutter enclosure were properly installed, configured, and secured; a reprimand letter from lab management to the user stating that tampering with a safety system is unacceptable and that willful disregard for adherence to safety policy will not be tolerated; and review of experimental area orientation procedures for adequate training on safety system configuration control.
