RSC Sub-committee To Investigate and Review ALS Shielding Control Procedures

RSC Sub-committee – Report

Wednesday, 18 January 2006

I. EXECUTIVE SUMMARY

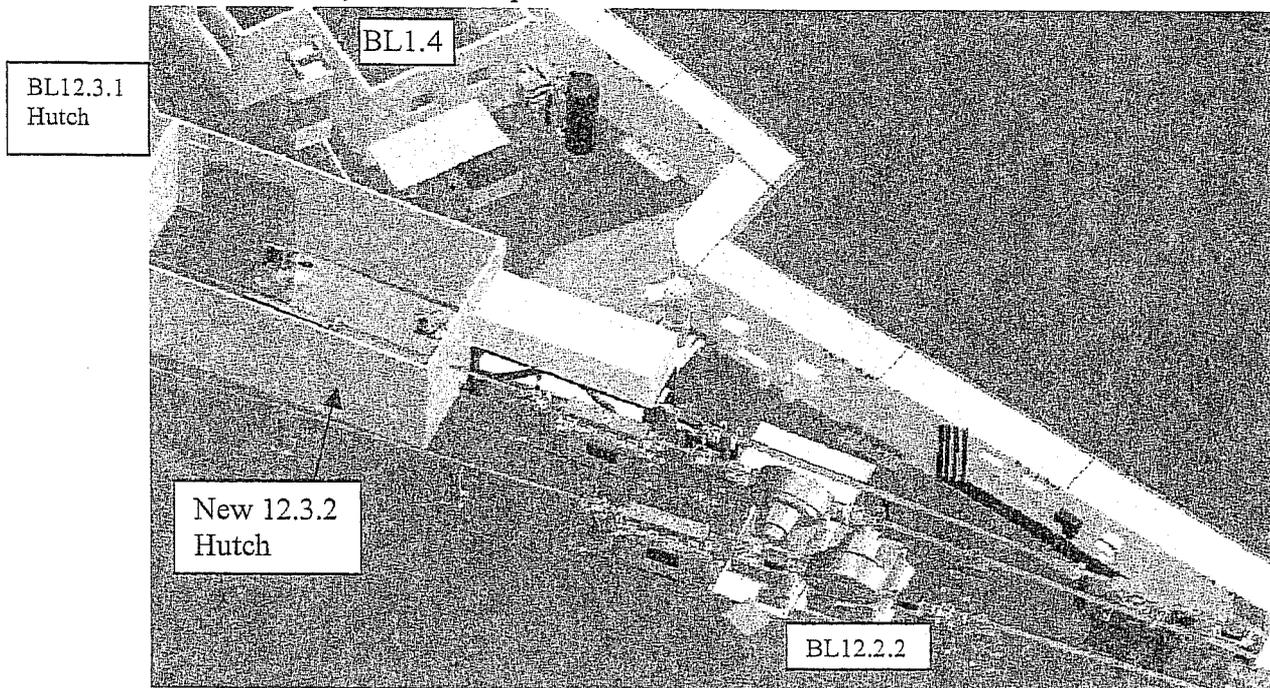
The motivation for the installation of the 12.3.2 superbend beamline was to move the micro-diffraction beamline 7.3.3 to 12.3.2 to get higher energy x-rays and smaller spot sizes, and to re-engineer the endstation for greater stability. Some but not all components within the 7.3.3 hutch were going to be reused. The 12.3.2 front-end was already in place through the shield wall up to a Be window as this was installed at the time of the 12.3.1 front-end install. The part on the ALS experimental floor was to be at high vacuum and to end just inside a lead-lined hutch with a 2nd Be window. The pink beam was to be in the experimental hutch which is why lead-lining was required.

Figure 1. Overview of the designed 12.3.2 beamline showing the new lead-lined hutch to be installed.
