Geologic Hazard Mitigation (Why It's Safe to Build at LBNL)

Wayne Magnusen, PE, GE

Alan Kropp & Associates, Inc.,
Berkeley, CA

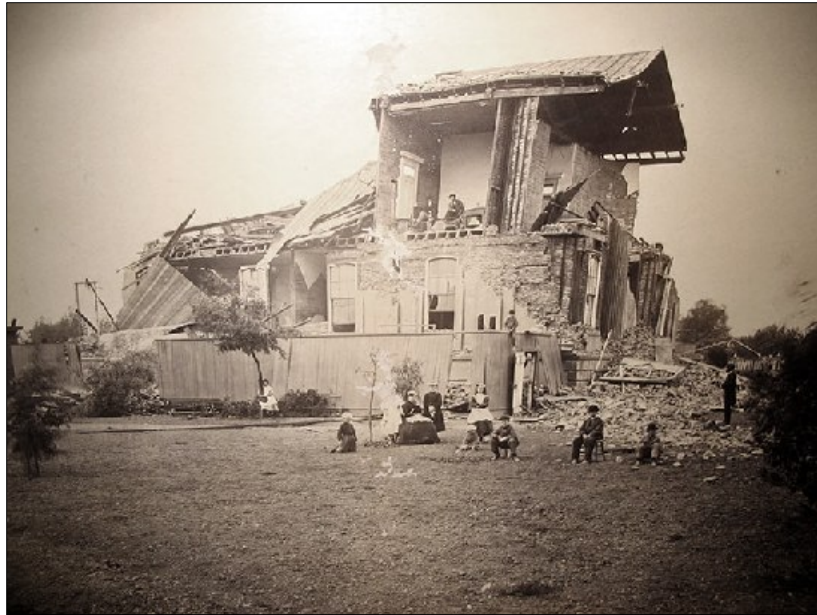
1868 Hayward Earthquake
Unreinforced Masonry

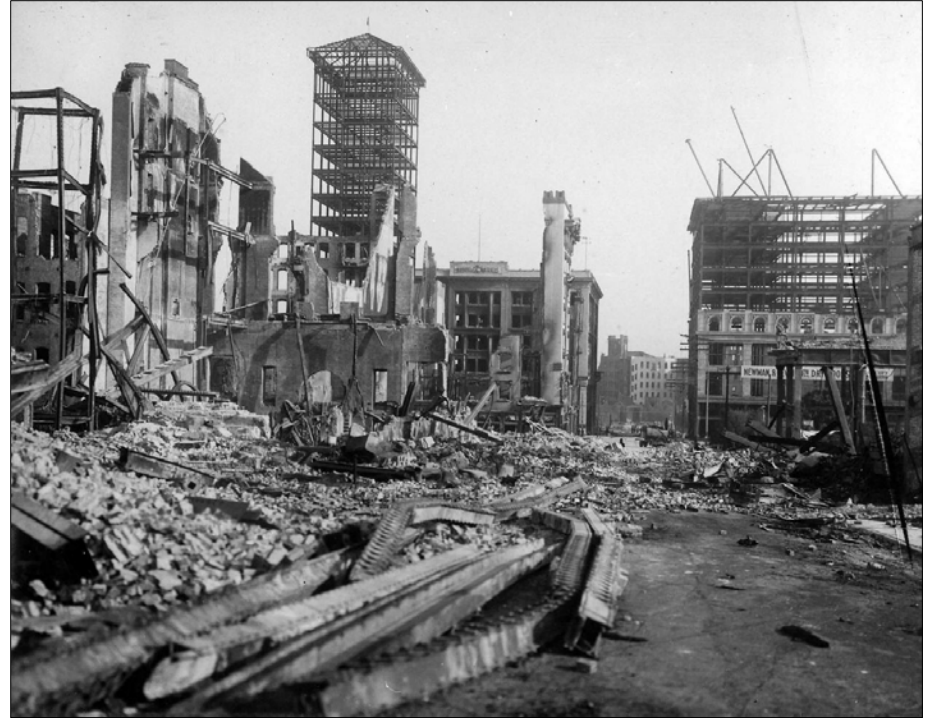
1906 San Francisco Earthquake
Emergence of the Steel Frame

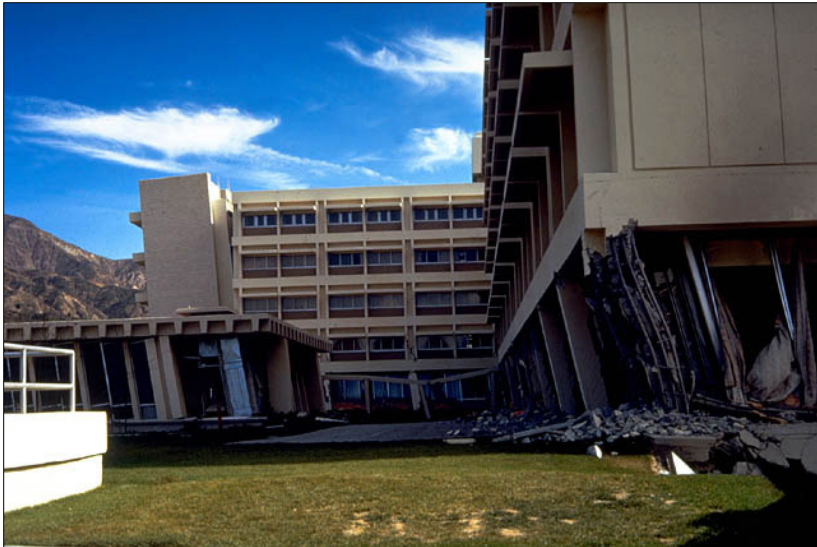
1971 San Fernando Earthquake
Soft Story

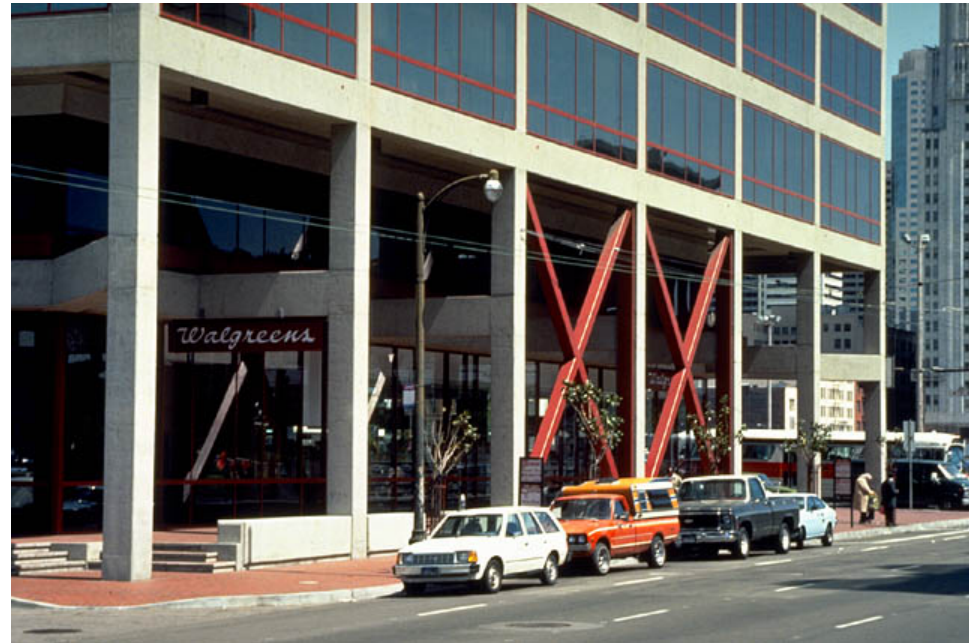
San Francisco
Soft Story Retrofit

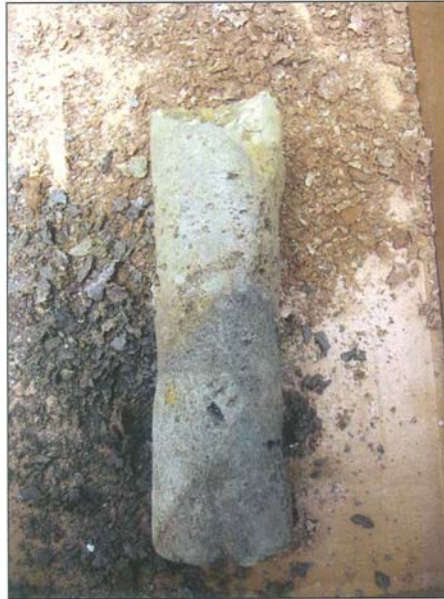
Photograph A-3. Core from boring AKA-9 at 30.5 feet showing a steeply inclined contact within the Orinda Formation.

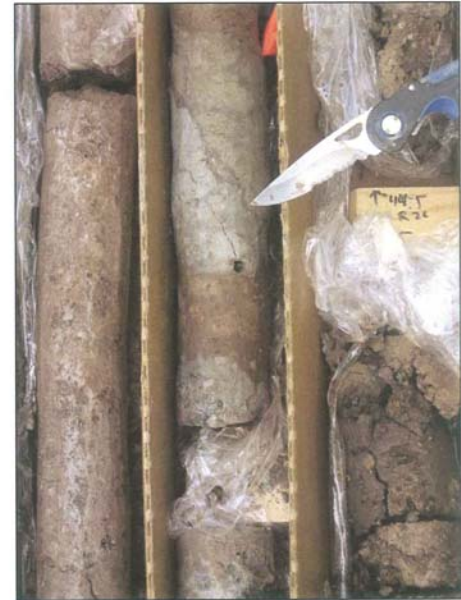
Photograph A-4. Core from boring AKA-9 at 45.5 to 46.5 feet showing approximate contact and shear between Moraga and Orinda Formations.
