Acta Materialia 50 (2002) 3579–3595

A reaction-layer mechanism for the delayed failure of micron-scale polycrystalline silicon structural films subjected to high-cycle fatigue loading

Abstract

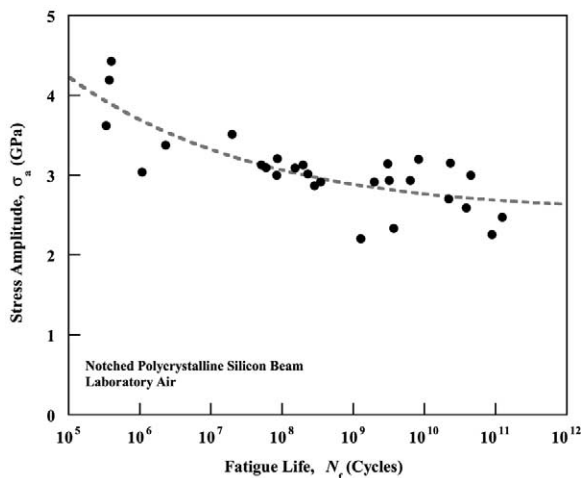
Fig. 3. Typical stress-life (*S/N*) fatigue behavior of the 2 μm -thick, polycrystalline silicon at ~ 40 kHz in moist room air under fully reversed, tension–compression loading [5].

Stress-life (*S/N*) data for the polycrystalline silicon films from ref. [5], based on a total of 28 fatigue specimens tested in room air, is shown in Fig. 3; fatigue lives, N_f , varied from ~ 10 sec to 34 days (3×10^5 to 1.2×10^{11} cycles) for stress amplitudes ranging from ~ 2 to 4 GPa at $R = -1$. Two specimens were interrupted prior to failure for examination in the HVTEM. It is apparent that the polycrystalline silicon films display ‘metal-like’ *S/N* behavior, with an endurance strength at 10^9 – 10^{10} cycles of roughly half the (single-cycle) fracture strength. Similar behavior has been seen in 20- μm thick films of single-crystal silicon cycled under similar conditions [4]. Stress-life fatigue tests were also conducted on specimens coated with the 1-octadecene monolayer. Thirteen specimens were tested to failure and five were interrupted prior to failure for examination in the HVTEM. Fatigue lives varied from ~ 7.5 sec to 25 days ($3 \times$

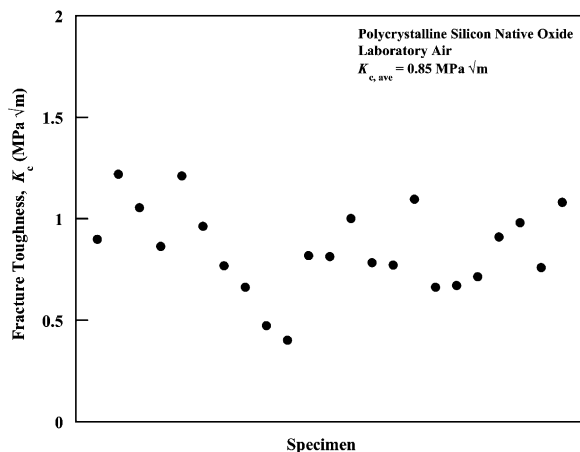
Fig. 11. Computed fracture toughness, K_c , values determined from the estimated crack length immediately prior to failure, i.e., from the critical crack size, a_c , for the given applied stress amplitude. The average fracture toughness of $0.85 \text{ MPa}\sqrt{\text{m}}$ is consistent with failure within the native oxide on polycrystalline silicon at room temperature.

fatigue tests (Fig. 11) give an average fracture toughness of $\sim 0.85 \text{ MPa}\sqrt{\text{m}}$, consistent with that of the native oxide [29]. However, it is important to note the relationship between the critical crack size at final failure, a_c , and the thickness, h_o , of the SiO_2 reaction layer when $K=K_c$. Such critical crack sizes are estimated in Fig. 12 for the range of maximum principal stresses used in this investigation. It is apparent that for applied stresses of 2 to 4 GPa, which caused failure in the present films after 10^5 to 10^{11} cycles, the critical crack sizes are less than 50 nm, i.e., comparable to, or less than, the observed oxide layer thicknesses (i.e., $a_c \leq h_o$). This indicates that the entire process of fatigue-crack initiation, propagation, and the onset of catastrophic (overload) failure all occur within the oxide layer.

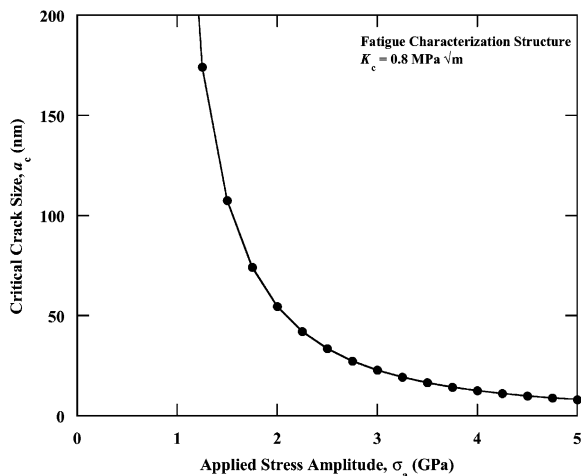
Fig. 12. Computed estimates of the critical crack size, a_c , as a function of the applied stress amplitude, σ_a , in the polycrystalline silicon fatigue characterization structure. Critical crack sizes for the stress amplitudes used in the present tests ($\sigma_a \sim 2$ to 4 GPa) are less than ~ 50 nm, indicating that the onset of final failure of the structure occurs at crack sizes within the native oxide reaction layer.

It is interesting to note that, in principle, the reaction-layer mechanism applies equally to bulk as well as thin-film silicon, even though bulk silicon is generally not considered to be susceptible to either stress-corrosion cracking or fatigue. Cracking in the nano-scale native oxide film has a negligible effect on a macroscopic sample of silicon under load since crack sizes in the oxide could never reach the critical size, i.e., $a_c \gg h_o$, where h_o is the native oxide thickness. In contrast, the surface-to-volume ratio is far larger in micro- and nano-scale samples. Consequently, the oxide layer represents a large proportion of the sample and cracks within the oxide film are readily able to exceed the critical crack size, i.e., $a_c \leq h_o$, as shown quantitatively in Fig. 12. Thus, cracking in the oxide layer alone can lead to failure of the entire silicon component.
